**THE VILLAS OF HATTERAS LANDING
HATTERAS, NC**

AUGUST 10, 2023

FULL RESERVE STUDY

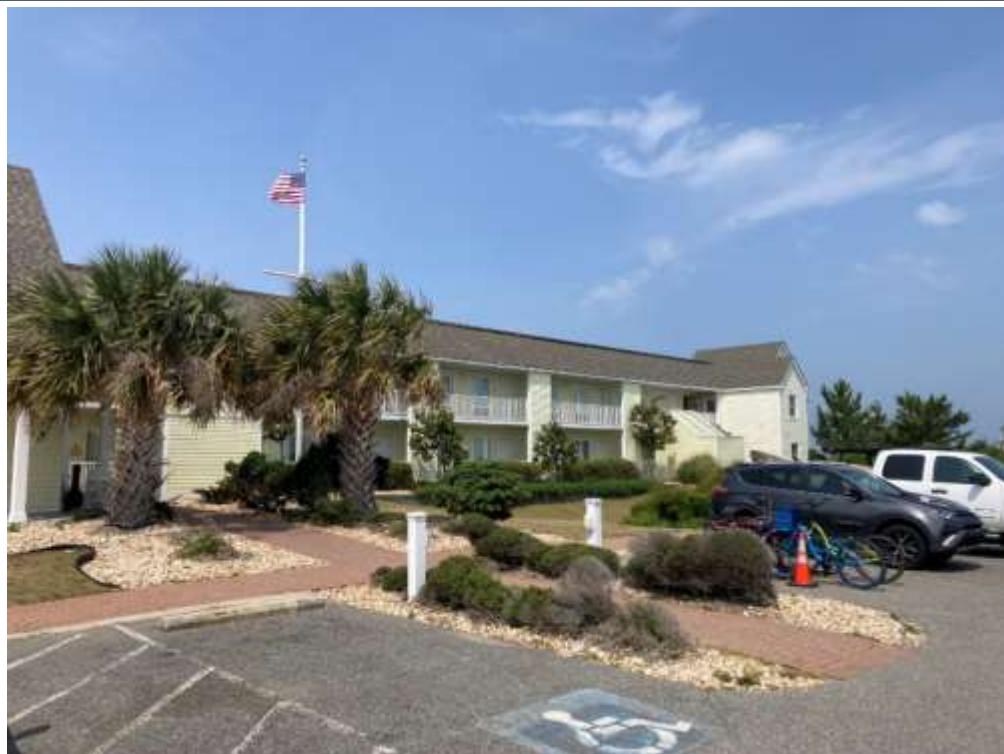
Photo No.
4

The building is covered in painted cedar shake siding and was noted to be in fair to poor condition. The paint coating on the siding was significantly faded, as well as flaking off in multiple areas. While the majority of the shakes appeared to be in generally good condition, some shakes were missing completely, and other areas had significant rot/damage to the shakes. Regular painting will help prolong the life of the siding. We have allocated funds for repairs and painting of the building exterior to occur on an 8-year cycle beginning in 2025. Exterior painting projects should include replacing any damaged trim and siding components, replacing any deteriorated caulking and sealants, adequate surface cleaning and preparation and the application of 2-coats of a high-quality exterior latex paint.

Typical view of shake
siding with deterioration

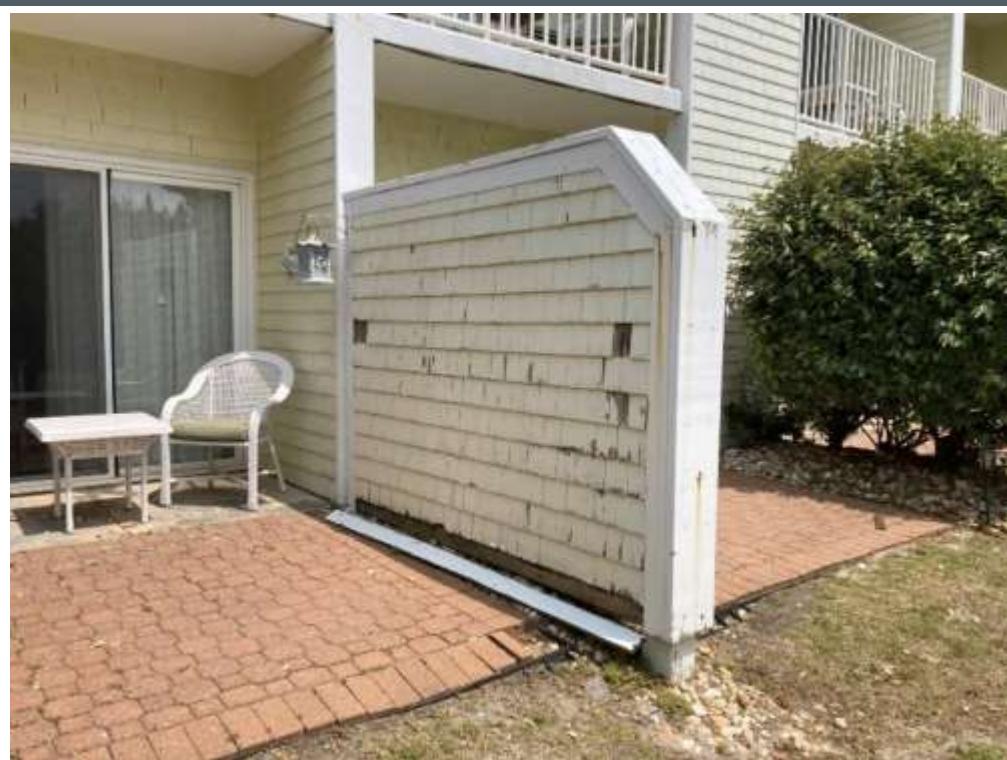
Photo No.
9

Typical view of shake
siding with deterioration

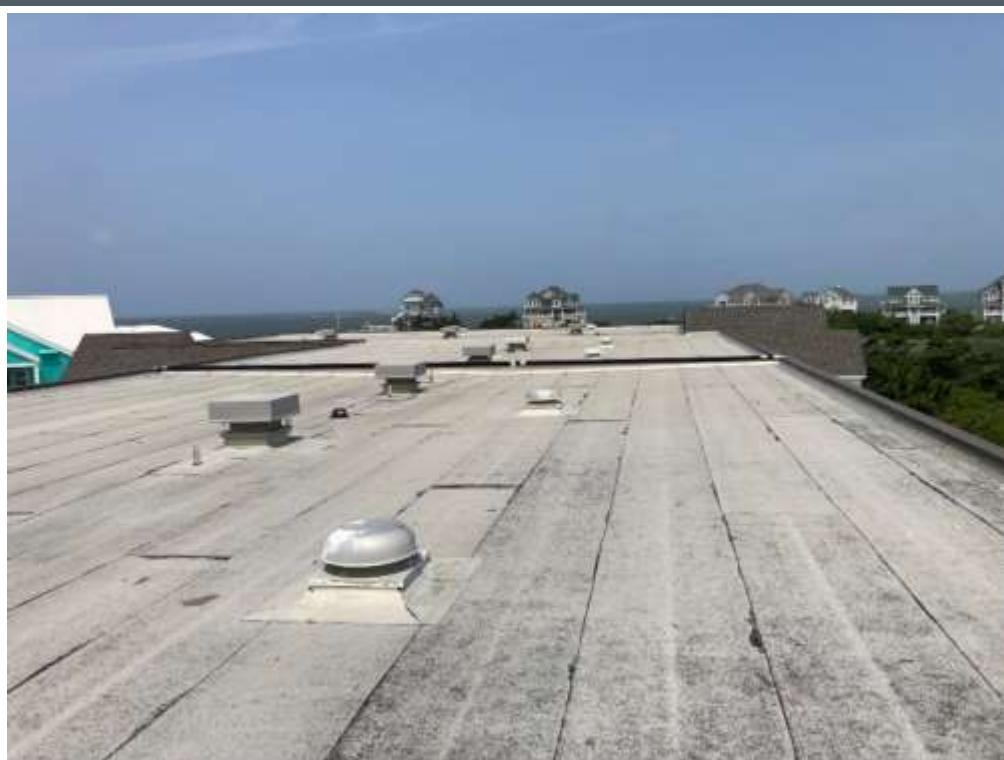
Photo No.
13

The predominant roof surface over the building is flat, and is covered in a modified bitumen membrane, with the perimeter roof sections being a pitched surface covered in architectural grade shingles. The shingle roof was reportedly replaced in 2023 and appears to be in good condition. The flashing cap is also scheduled for 2023 replacement. We are unaware of any concerns with current or previous roof leaks. We recommend setting aside money in the general operating budget to inspect and repair roofing concerns annually. Minor improvements will likely include replacing vent boots, flashing and drip edge repairs, and internal drain repairs.

Typical view of
transition between
shingles and flat roof

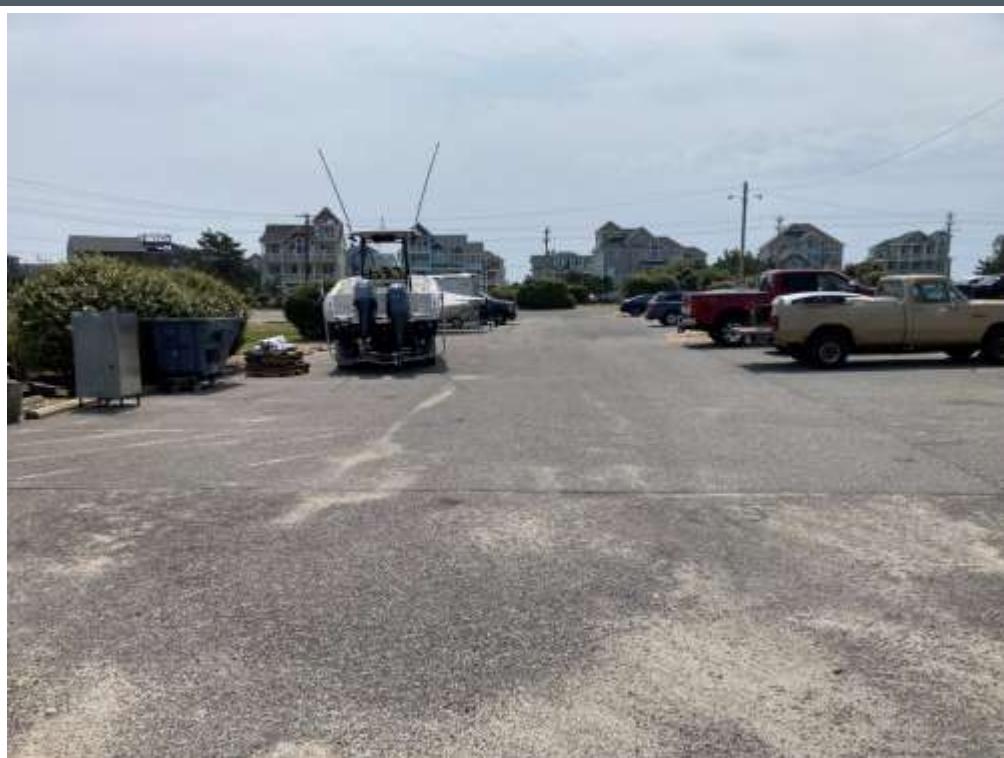
Photo No.
27

The asphalt paving including a portion of Marina Way and the parking areas throughout the community are privately maintained. The asphalt surfaces were noted to be in generally fair condition and likely original to construction of the property (1996). Cracks were noted in multiple locations, primarily in the main parking lot, and significant oxidation (long-term deterioration from weathering) was present throughout the paved surfaces.

Cracking in asphalt parking lot

Typically, we recommend the application of an oil resistant sealant to all asphalt parking area surfaces on an approximately 7-year cycle. At this same time, all cracks should be properly filled, patched, and sealed, and the parking spaces re-striped. We have allocated funds to crack fill, seal coat, and paint the asphalt parking lot beginning in 2036. Note that this is seven years after the estimated resurfacing, because crack filling and sealing at this point in the pavement's life would have minimal effect to extend the life. We have not included funds for sealing Marina Way.

The asphalt paving is at the end of its expected useful life. Generally, asphalt paved roads and parking areas have an expected useful life of approximately 20 to 25 years prior to resurfacing. Resurfacing the asphalt should include milling to remove the top 2-inches of asphalt paving in all areas, repairing sub-grade/base courses as needed and installing a new 2" thick layer of asphalt paving. We have allocated funds to resurface the asphalt paving in 2029.
